November 25, 2015

Re: Beazer Monitoring Well HG-29D
Cabot Carbon/Koppers Superfund Site, Gainesville, Florida

Concentration Temporal Trends at HG-29S/HG-29D

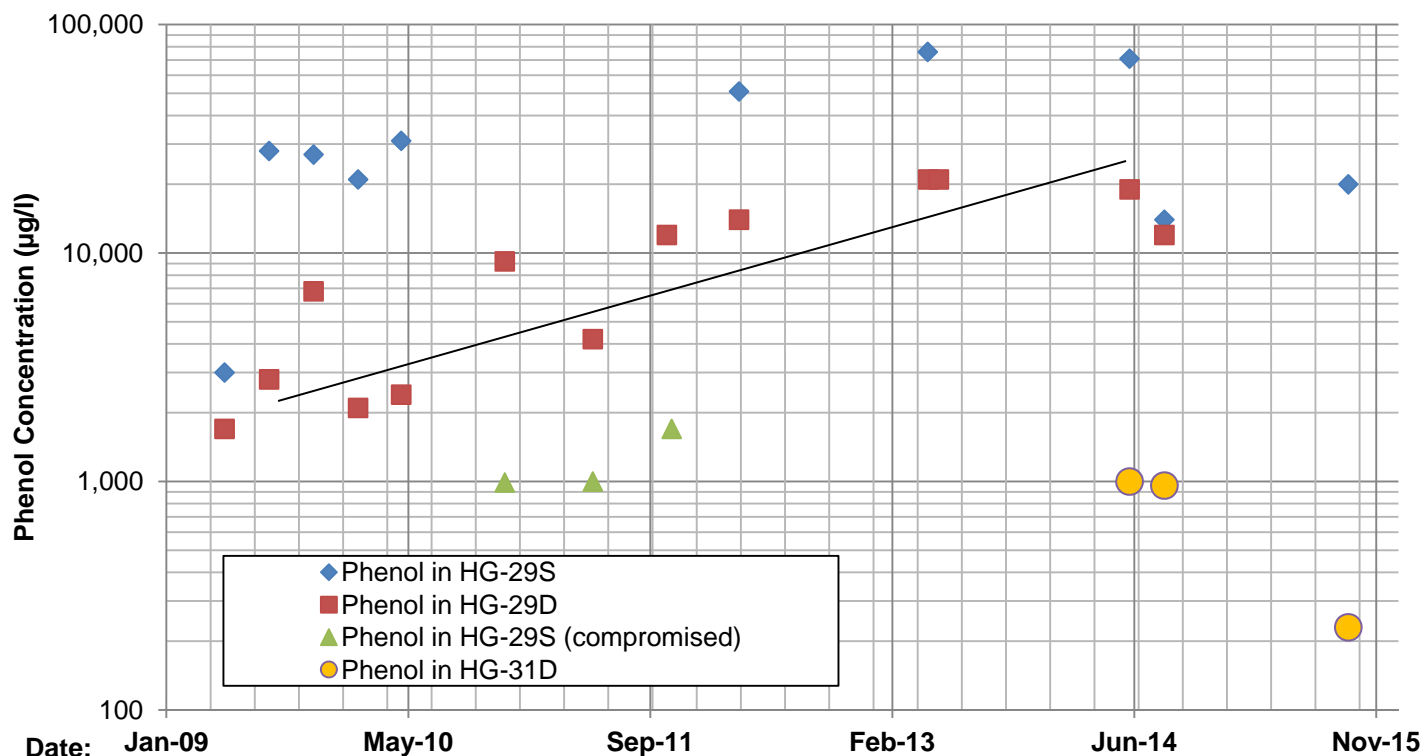
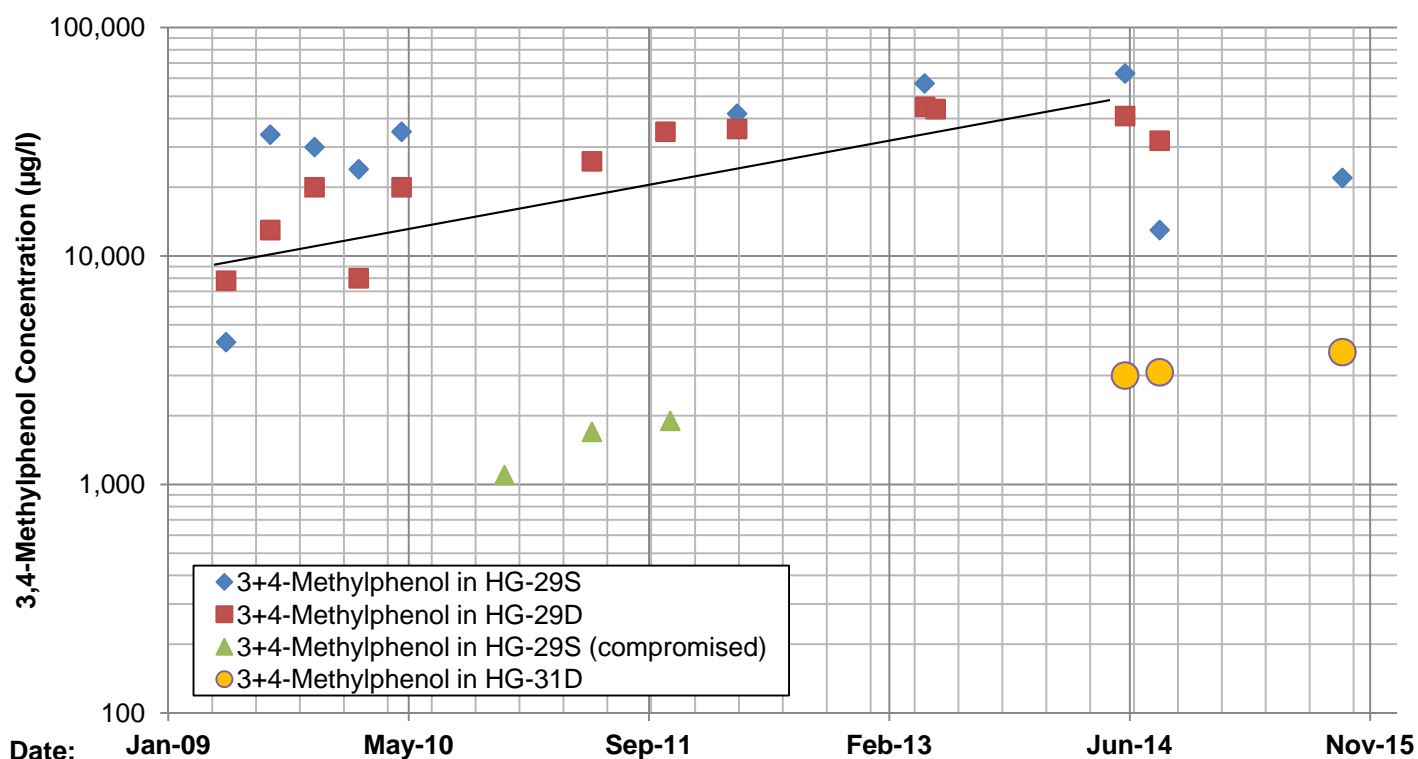
FIGURE 1

Groundwater concentrations for key pine processing compounds (*e.g.*, phenol, 3,4-methylphenol) at HG-29D have increased by more than order of magnitude and are now approaching concentrations observed in the paired Upper Hawthorn Group (UHG) monitoring well, HG-29S (Figure 1). In contrast, groundwater concentrations at the other LHG monitoring wells near and/or downgradient of the former Cabot lagoons (HG-30D, HG-31D, and HG-28D; Figure 2) are much lower and are stable. In fact, monitoring well HG-31D was installed immediately upgradient of HG-29D, and as close to the former Cabot lagoons as possible, with the sole purpose of replacing the compromised well (HG-29D). Groundwater concentrations at this replacement well continue to be significantly lower than at HG-29D (Figure 1). This difference in both the magnitude of observed groundwater concentrations and the difference in the temporal trend between the two monitoring wells, located less than 40 feet apart, is being caused by the leaking seal at HG-29D.

Overall, a consideration of all the groundwater quality data collected in the LHG monitoring wells at the Cabot portion of the Site clearly demonstrates that the observed concentrations and temporal trends at HG-29D are anomalous, and are being caused by a leaking well seal.

▲ Indicates samples were compromised due to surface water infiltration at the well cap.

In summary, HG-29D cannot be plugged and abandoned in accordance with the Cabot work plan (Gradient and Weston, 2014)² because of the well's improper construction. As discussed above, groundwater quality temporal trends at HG-29D and a comparison to trends observed at other LHG wells clearly indicate that the monitoring well is serving as a preferential conduit for contaminant migration and needs to be plugged and abandoned. We would appreciate US EPA's assistance in getting Beazer to promptly plug and abandon this well.
