RE: GRU Comments to GeoTrans' Work Plan entitled *Field Investigation of Historical Linear Features Identified from Aerial Photographs and Potential Drum-Disposal Areas, Koppers Inc. Site, Gainesville, Florida* dated October 11, 2010

GRU & City of Gainesville Comments to GeoTrans' Work Plan entitled: *Field Investigation of Historical Linear Features Identified from Aerial Photographs and Potential Drum-Disposal Areas, Koppers Inc. Site, Gainesville, Florida* dated October 11, 2010

Annotated Aerial Photographs of Former
South Lagoon Area

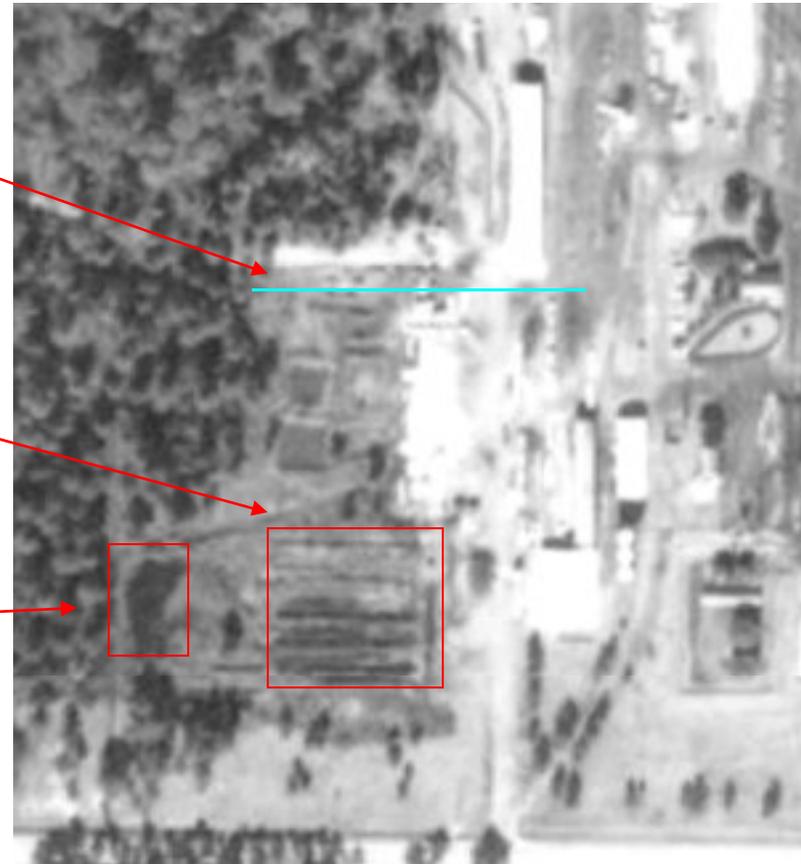
Koppers South Lagoon 1961

The attached aerials illustrate these. The 5 East-West parallel linear features are first visible in the 1956 aerials¹ (not visible in the 1949 photos). They are also visible in aerials taken in 1961 (attached) but were largely covered in 1968 (attached).

distance across the features (their width) is less than the distance between them – meaning that less than half the area in the red box on the photographs is occupied by the features themselves. It is possible that the previous soil borings were drilled between them. We believe Beazer should conduct geophysical surveys in this area and excavate test pits at anomalies – if any are identified. At a minimum, one linear test pit is needed oriented perpendicular to the linear features (as is proposed for the linear features north of the north lagoon).

Lagoons extend north almost to south end of metal kiln in 1971 photo.

Approx. location E-W linear features.

Former pond west of linear features.

Per our Comment 4 (above), we believe the linear features, the previously unidentified pond, and northern end of the Former South Lagoon complex should be characterized before remedial design is completed. Including these features in this work plan would be a logical and reasonable start to that investigation.

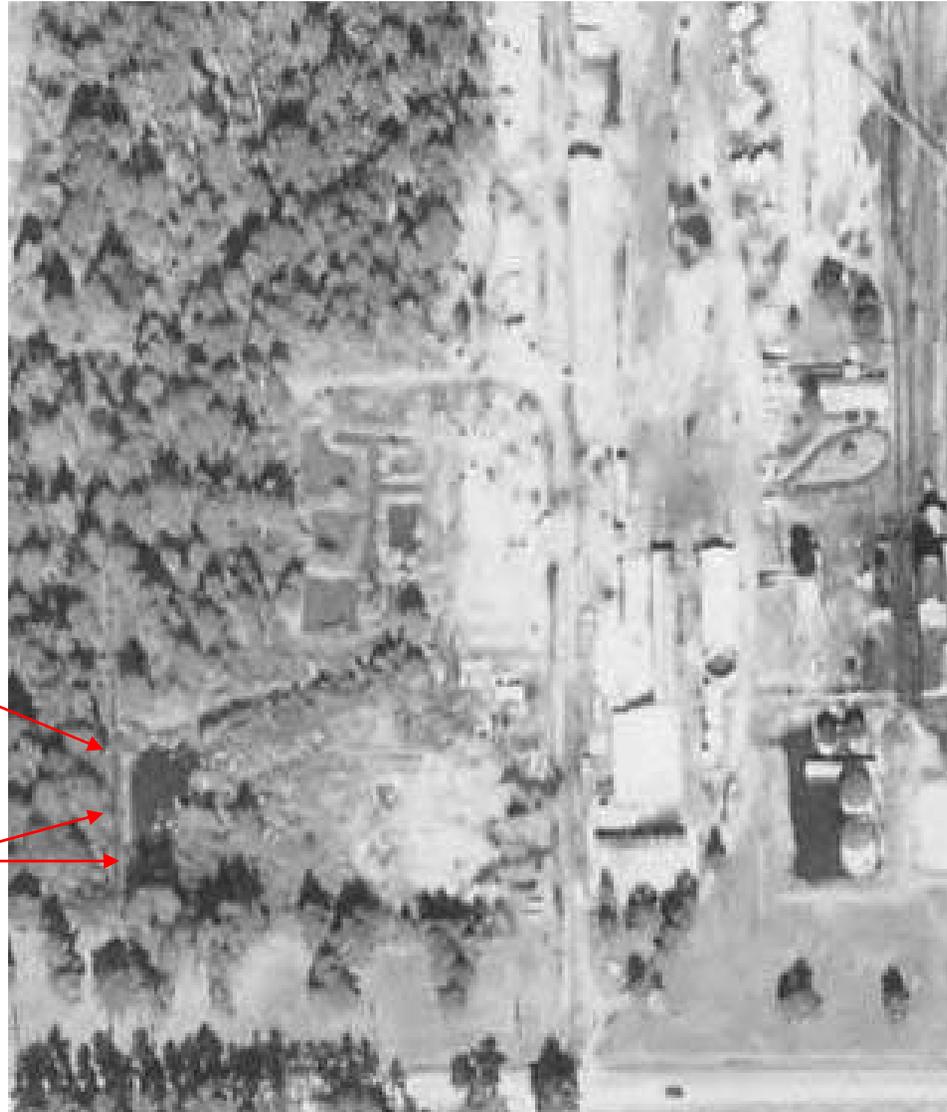
Koppers South Lagoon 1968

The previously unidentified pond is visible in the 1961 and 1968 aerials and is outside the mapped Former South Lagoon. The pond appears to be west of the area investigated by soil borings and test pits (as reported in the DNAPL Source Zone Evaluation report dated September 2004). See the attached aerial photos^{2,3}. Boring CPT-43S is south of the pond.

**Former pond
west of linear
features.**

**Note difference
between pond
and shadows.**

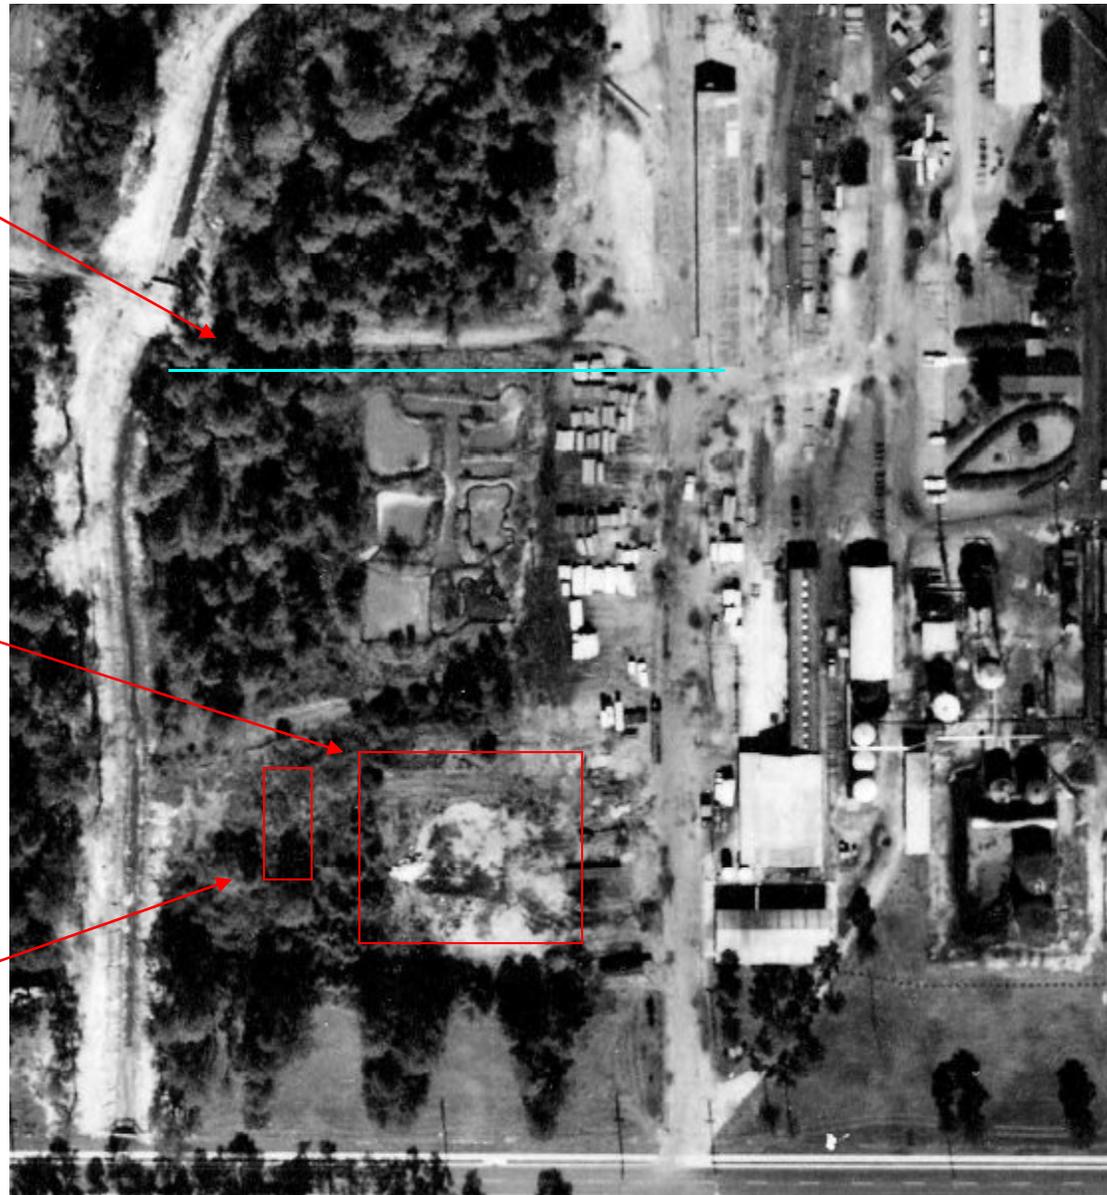
Koppers South Lagoon 1971

The complex of lagoons at the Former South Lagoon area extends north to a line even with the south end of the metal kiln building (see attached annotated aerial photographs). In comparing these photos with Figure 3 of the 2001 DNAPL Source Zone Evaluation report, it appears that only boring CPT-44S is within the northern 250 ft of the area formerly occupied by the South Lagoons (boring CPT-38 is probably east of the lagoons). Additional characterization of subsurface conditions is needed in this sparsely sampled part of the Former South Lagoon complex.

Lagoons extend north almost to south end of metal kiln.

Approx. location E-W linear features.

Approx. location former pond west of linear features.

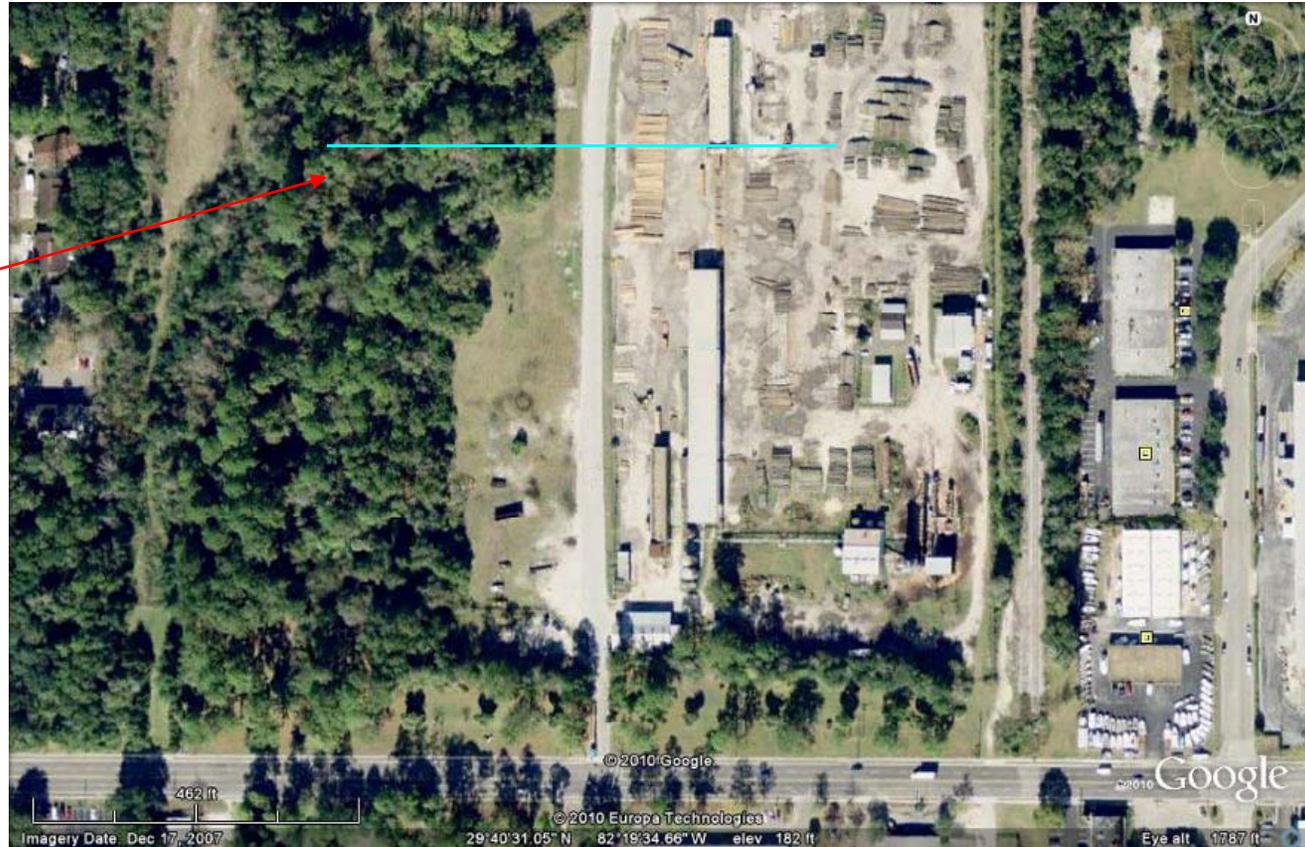
Koppers South Lagoon circa 2009

Northern
extent of
lagoons:
1971 photo.
