Remedial Action Work Plan: Off-Property Soil Replacement Block K

Cabot/Koppers Superfund Site

Operable Unit Five (Koppers)

Gainesville, Florida

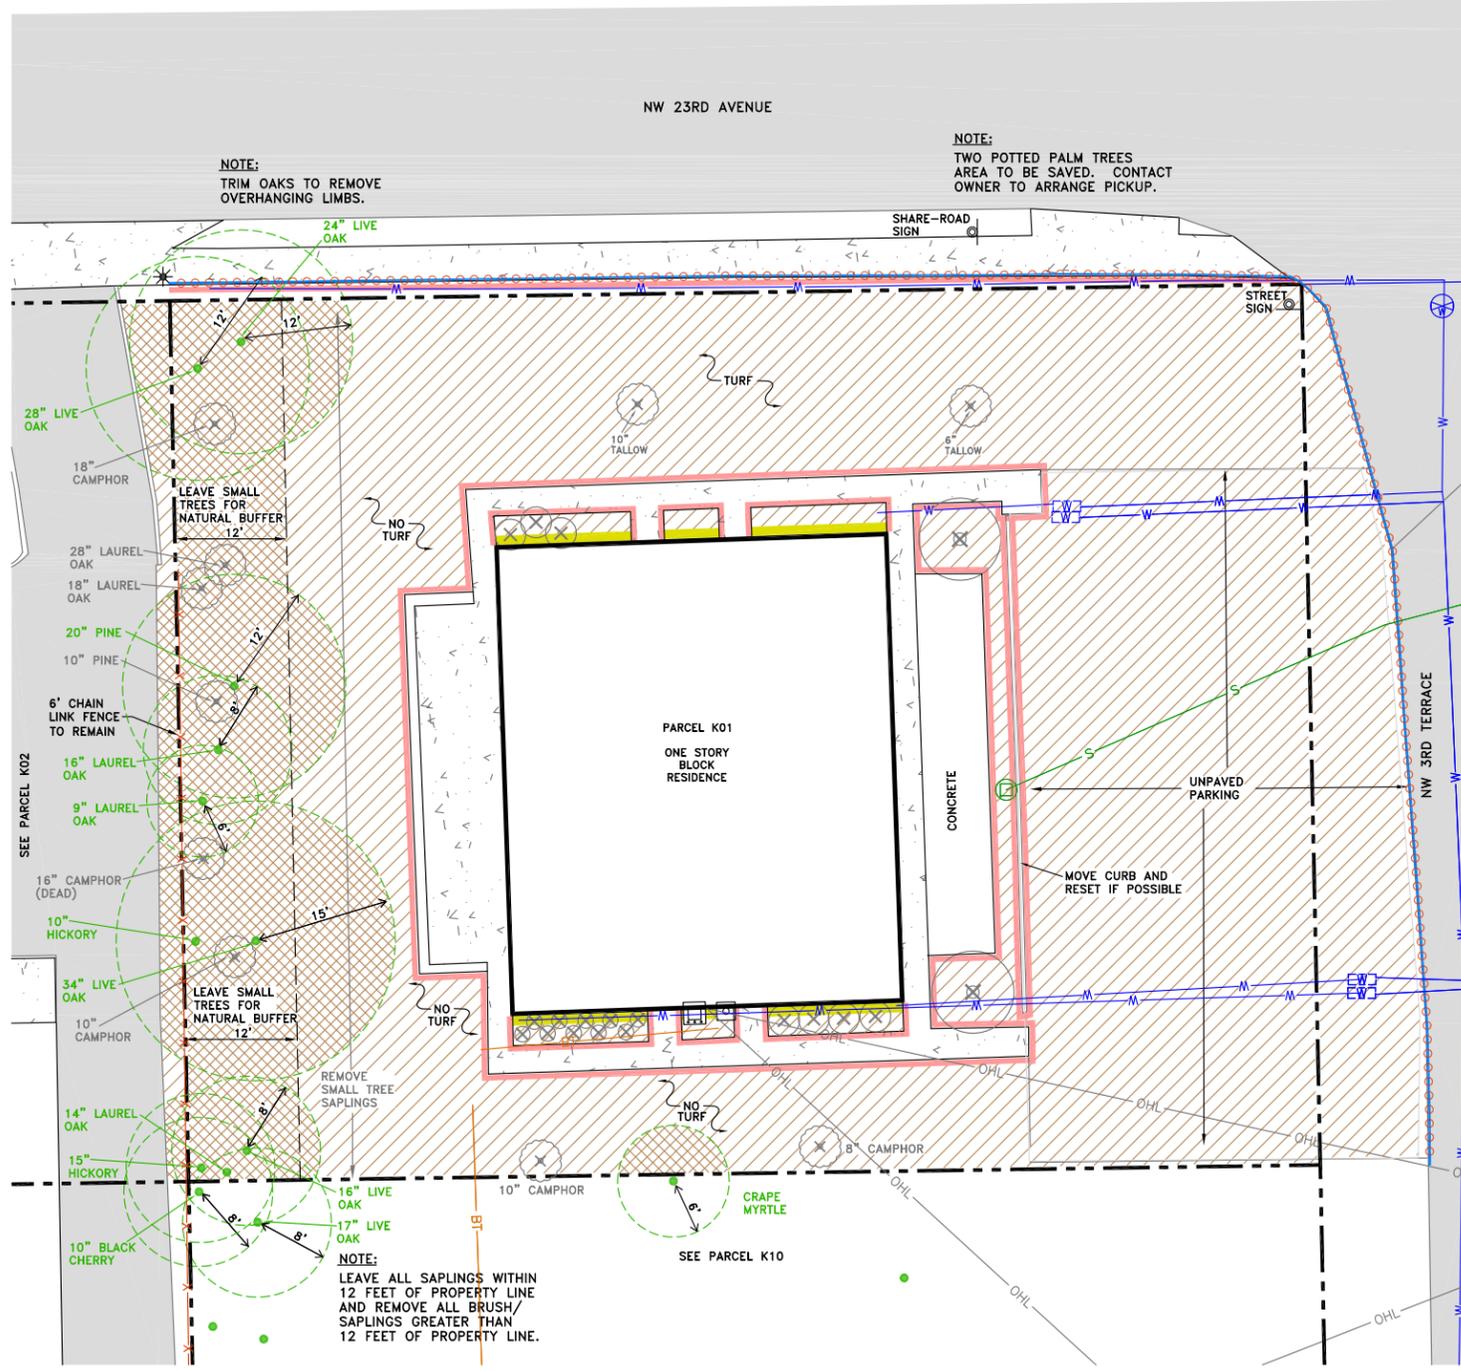
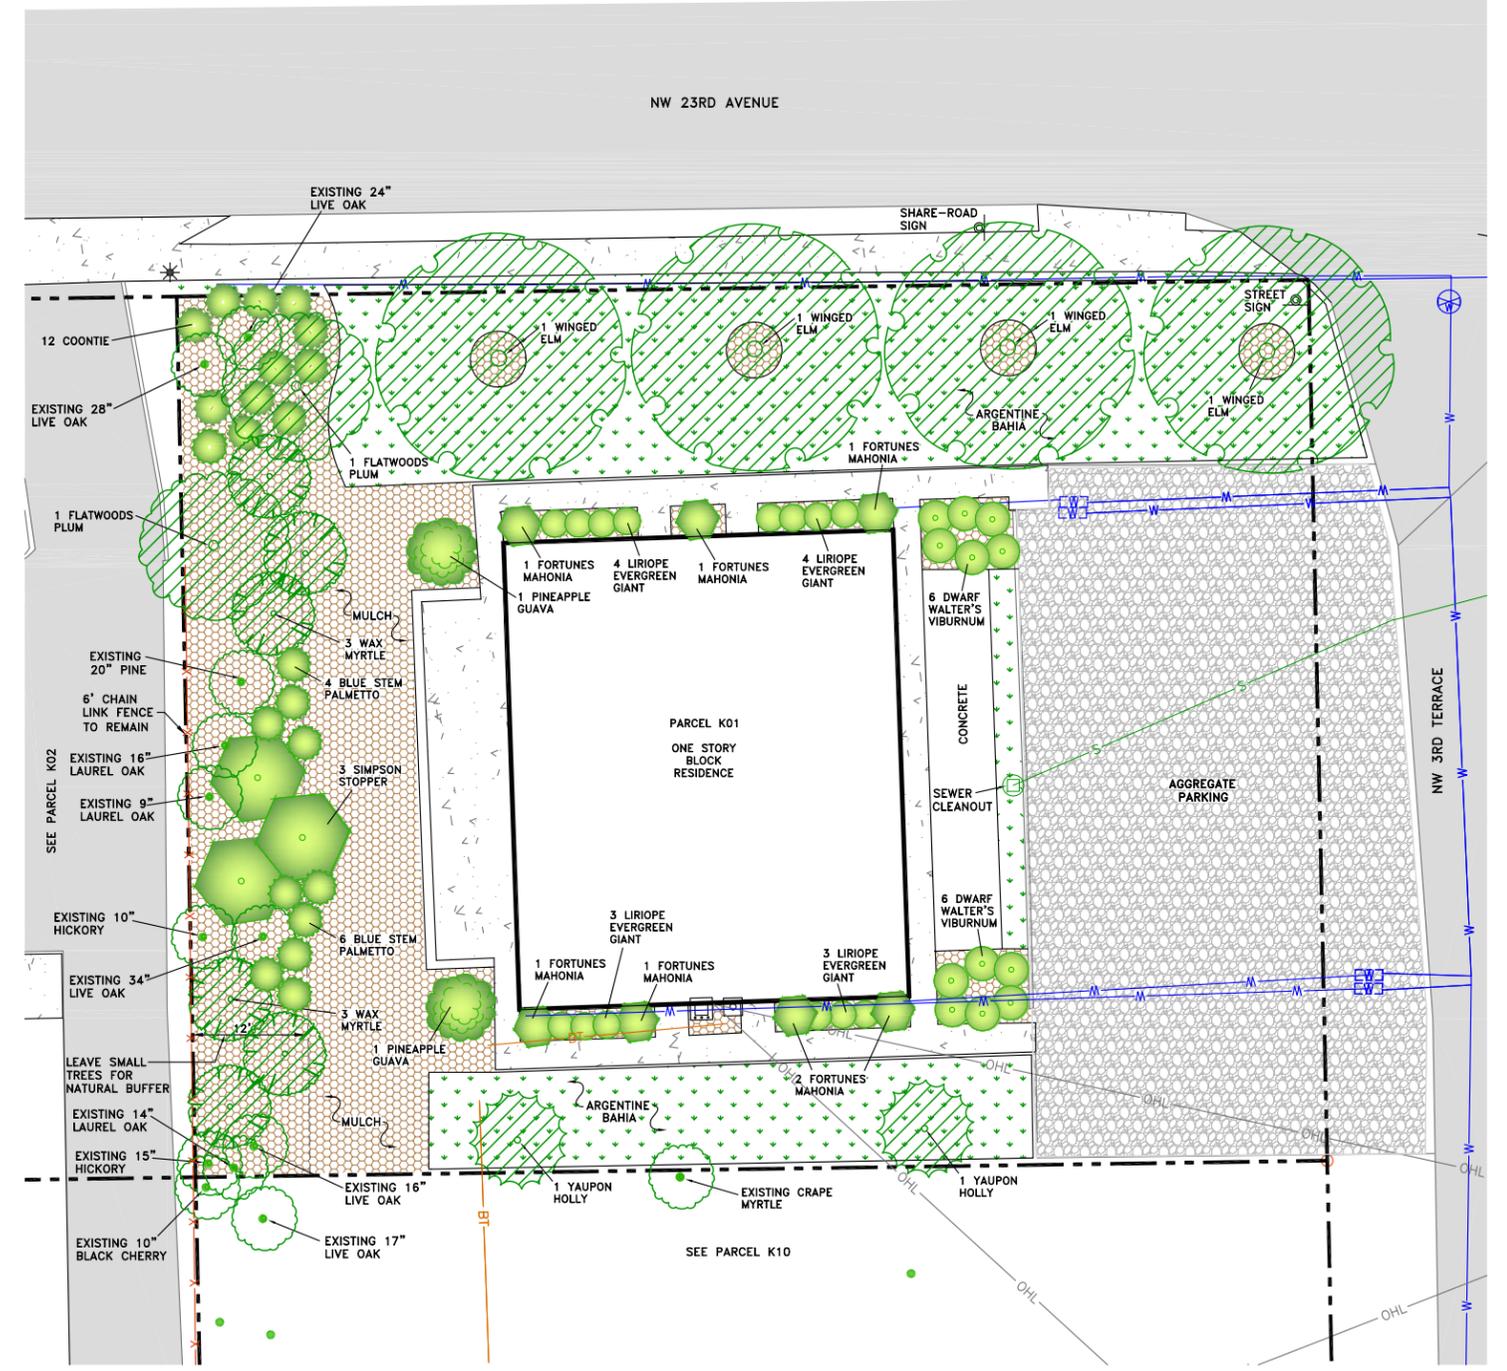
EXISTING CONDITIONS AND SOIL REMOVAL PLAN

RESTORATION PLAN

- GRAVEL AREA = 295 S.F.
- ARGENTINE BAHIA SOD
- PINE BARK MULCH
- PROPERTY LINE
- EXISTING 6' CHAIN LINK FENCE
- EXISTING TREE
- NEW TREE
- NEW TREE OR SHRUB
- UTILITIES
 - OHW OVERHEAD UTILITY LINES
 - SS UNDERGROUND SANITARY SEWER (APPROX.)
 - WM UNDERGROUND WATER MAIN (APPROX.)
 - GAS UNDERGROUND NATURAL GAS (APPROX.)
 - BT UNDERGROUND TELEPHONE (APPROX.)
 - EL UNDERGROUND ELECTRIC (APPROX.)
 - UNK UNDERGROUND UNKNOWN (APPROX.)
- DATE
- REVISION
- TITLE: **K01 SOIL RESORATION PLAN**
- LOCATION: **2216 NW 3RD TERRACE Gainesville, Florida**
- APPROVED: GC
- DRAFTED: CP
- PROJECT#: 117-2201319
- DATE: 8-15-14
- FIGURE: **3-1**

The left side of each drawing shows existing conditions determined by a physical feature and topography survey (conducted by George F. Young) and a landscaping assessment (conducted by a local professional landscape architect firm, Zamia Design, and a local arborist from Kestrel Ecological Services). The left side of the figure shows:

The right side of each drawing shows the restoration plan to be implemented after replacement of clean soil to existing grade. Each plan has been approved by the property owners. This depiction includes:

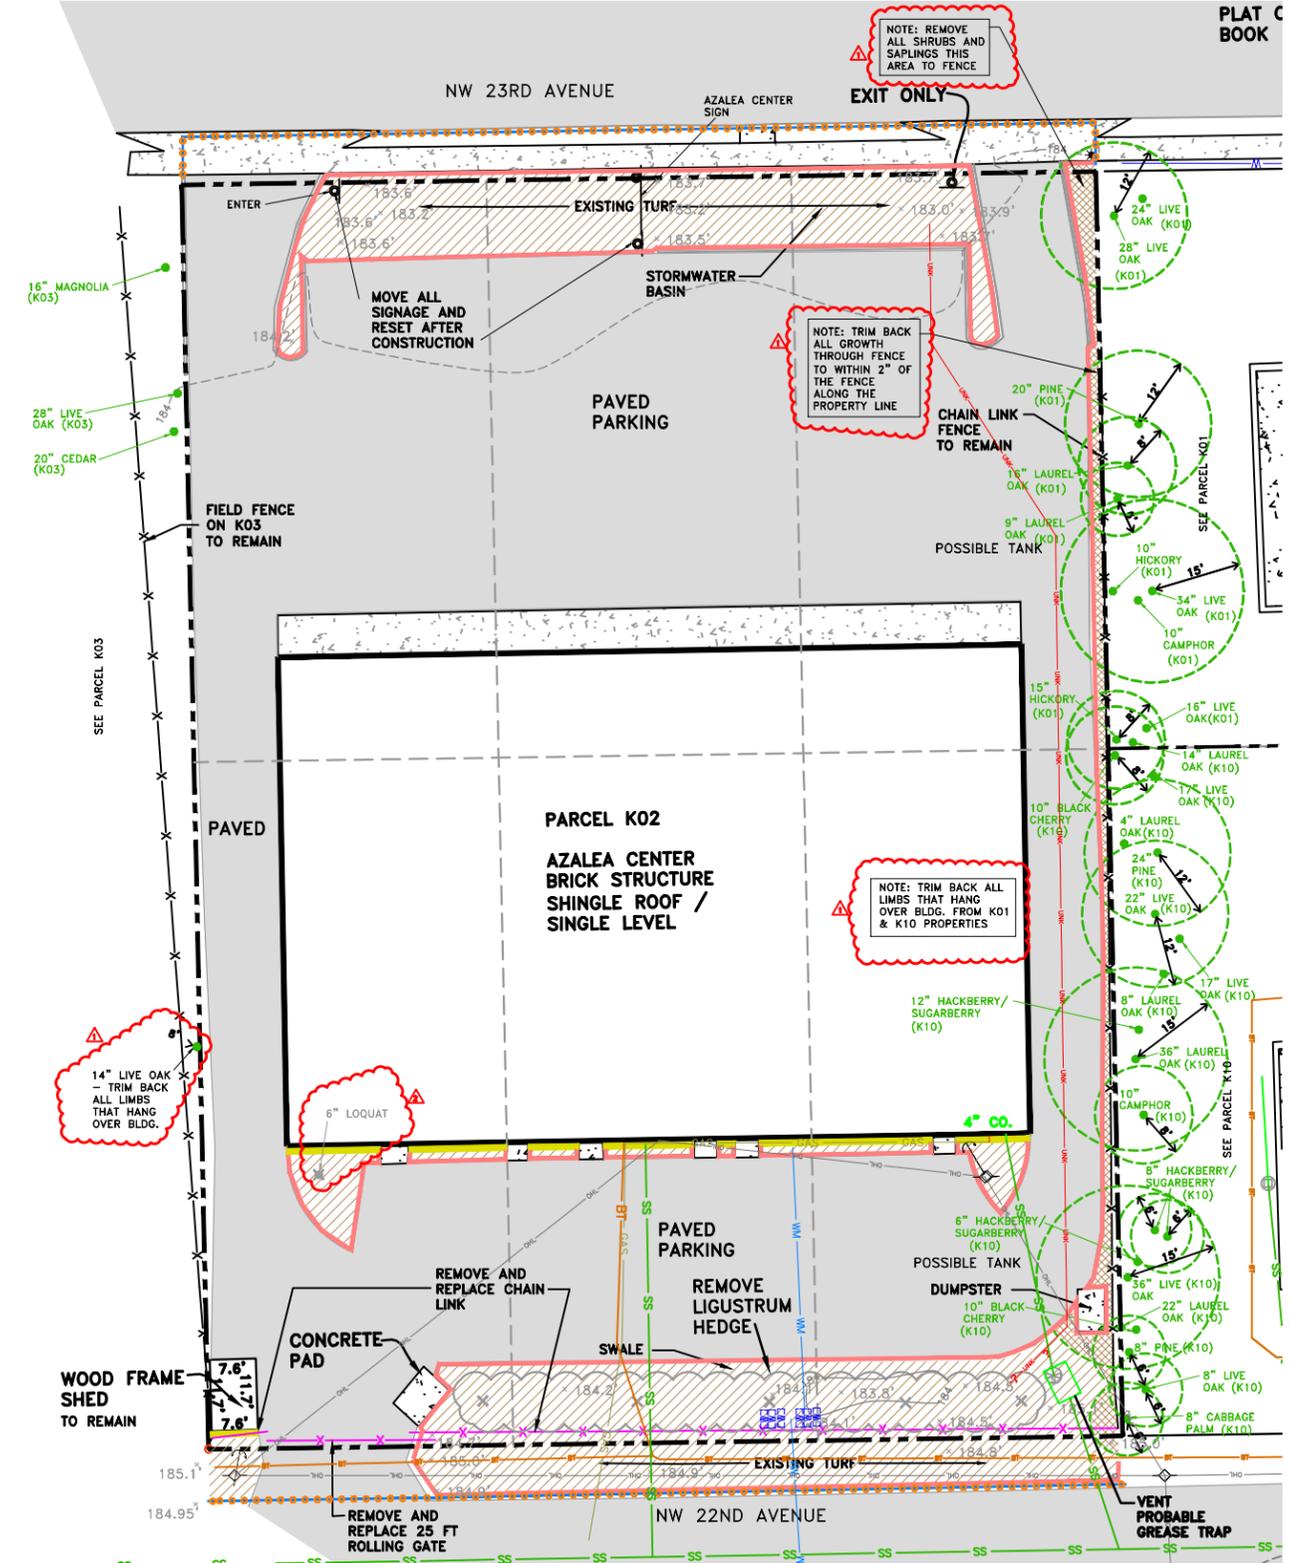
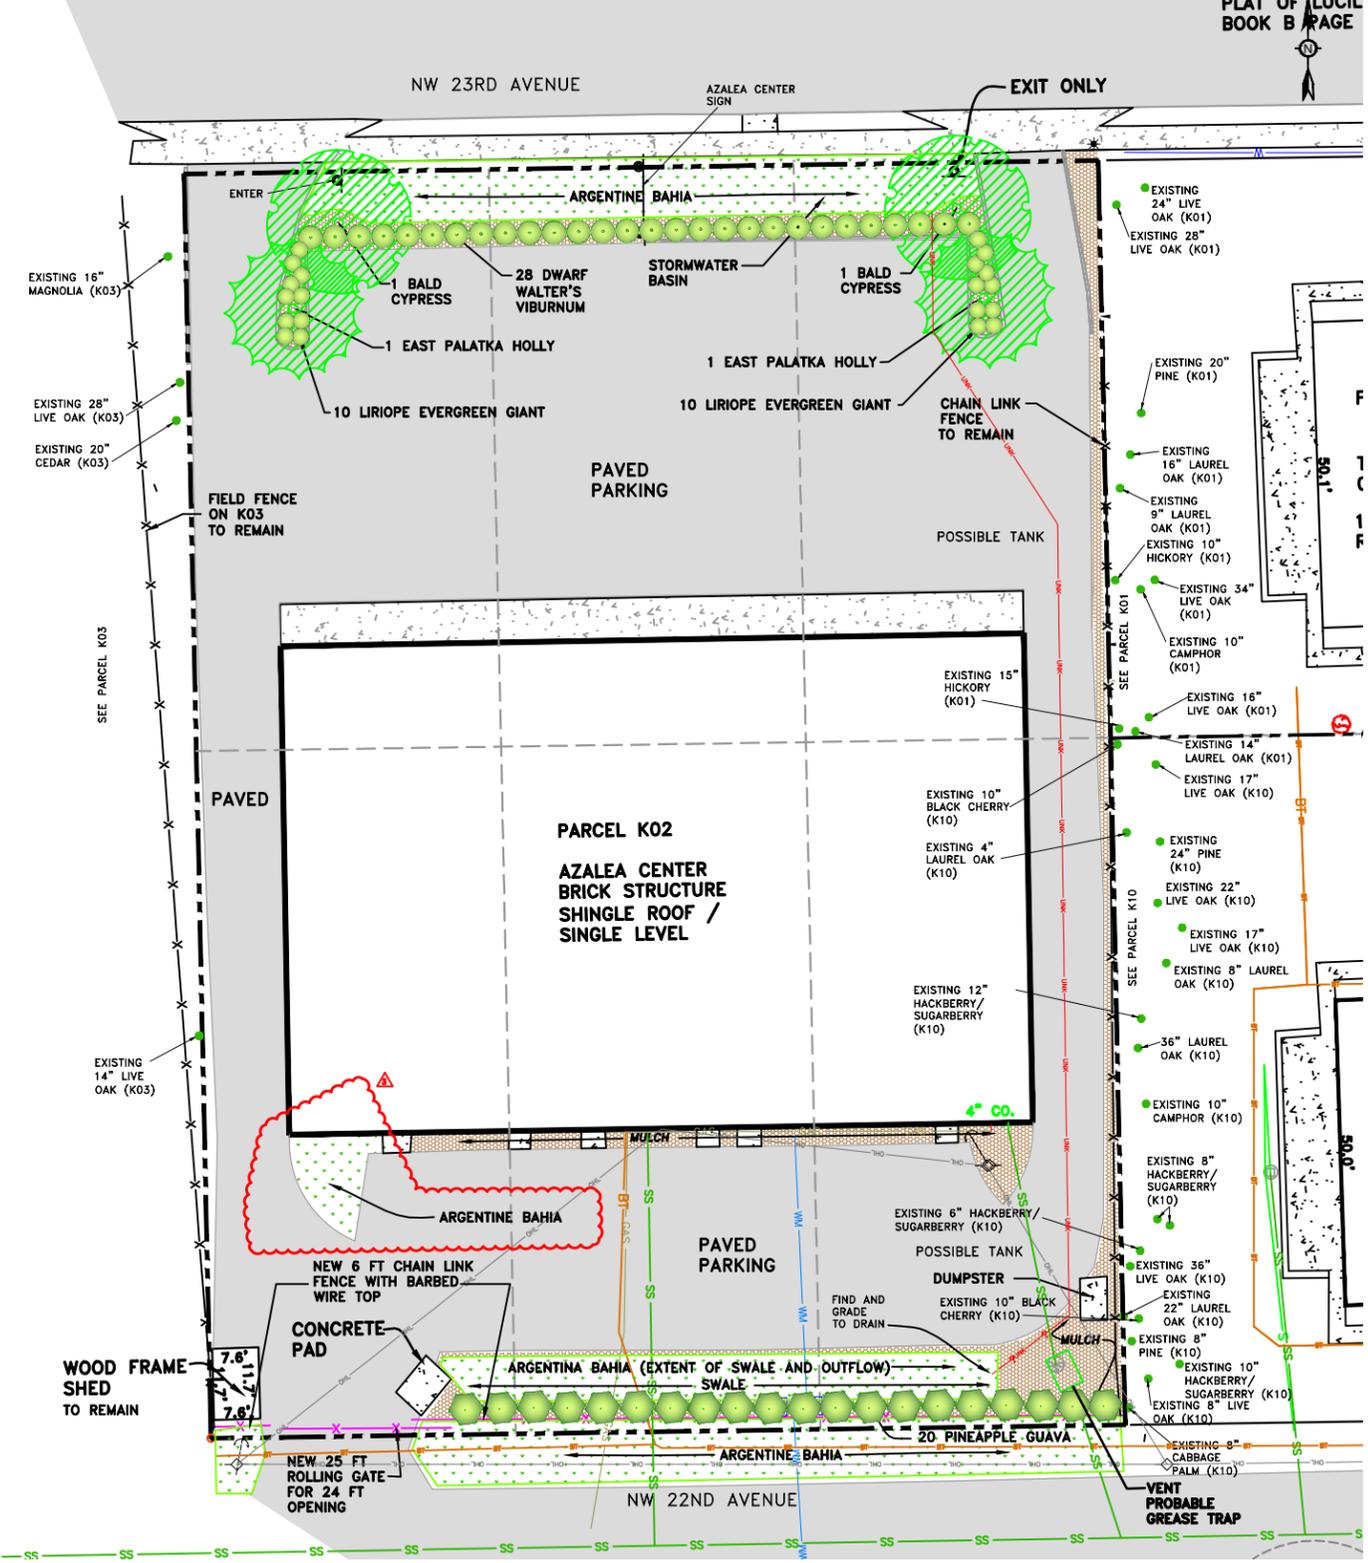
TITLE: K02 SOIL RESORATION PLAN		FIGURE
LOCATION: 501 NW 23rd Avenue Gainesville, Florida		3-2
	APPROVED GC	DATE: 8-18-14
	CP - RK	
	PROJECT# 117-2201319

EXISTING CONDITIONS AND SOIL REMOVAL PLAN

- LEGEND**
- PROPERTY LINE
 - BRUSH OR RAKE TOPSOIL TO ROOT MAT. REPLACE IMMEDIATELY. AREA = 450 S.F.
 - 1 FT SOIL REMOVAL AREA AREA = 4,100 S.F.
 - CHAIN LINK FENCE WITH BARBED WIRE TOP REMOVE AND REPLACE

RESTORATION PLAN

- LEGEND**
- ARGENTINE BAHIA SOD
 - PINE BARK MULCH
 - PROPERTY LINE
 - NEW 6 FT CHAIN LINK FENCE WITH BARBED WIRE TOP LENGTH 149 FT.
 - CHAIN LINK FENCE TO REMAIN
 - EXISTING TREE
 - NEW TREE
 - NEW TREE OR SHRUB
 - UTILITIES
 - OHW OVERHEAD UTILITY LINES
 - SS UNDERGROUND SANITARY SEWER (APPROX.)
 - WM UNDERGROUND WATER MAIN (APPROX.)
 - GAS UNDERGROUND NATURAL GAS (APPROX.)
 - BT UNDERGROUND TELEPHONE (APPROX.)
 - EL UNDERGROUND ELECTRIC (APPROX.)
 - UNK UNDERGROUND UNKNOWN (APPROX.)

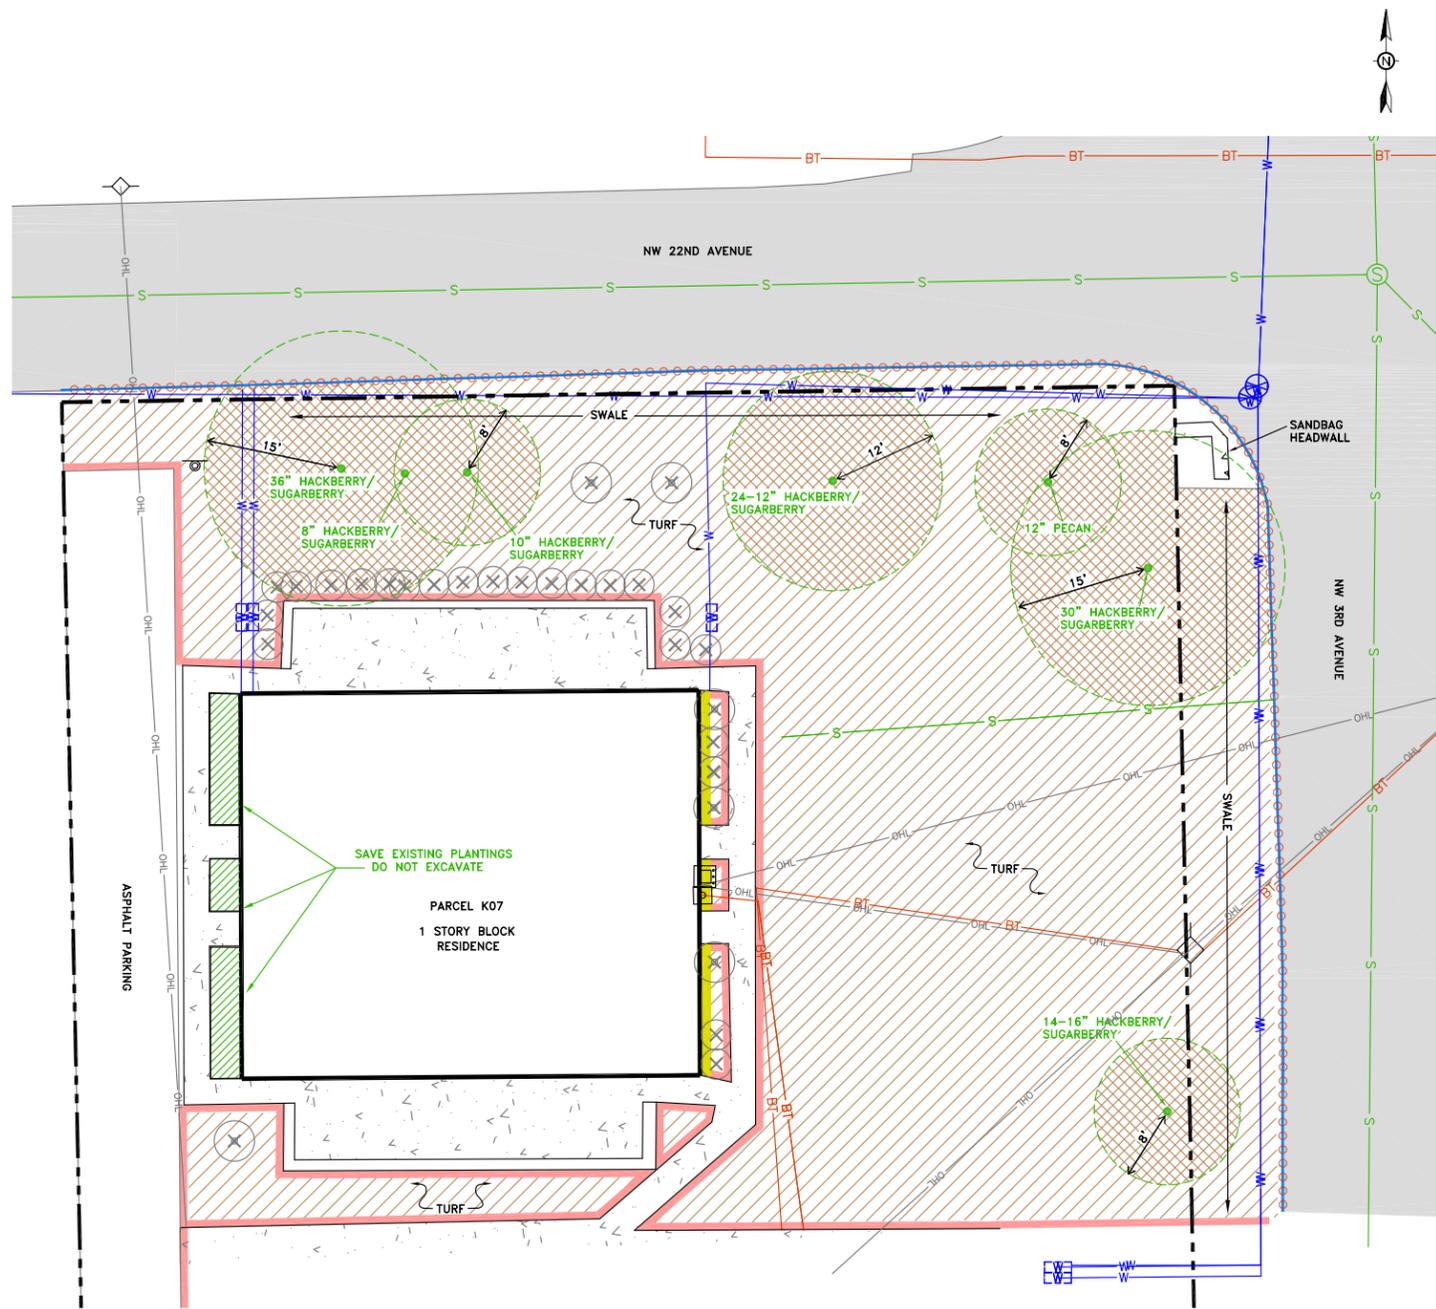
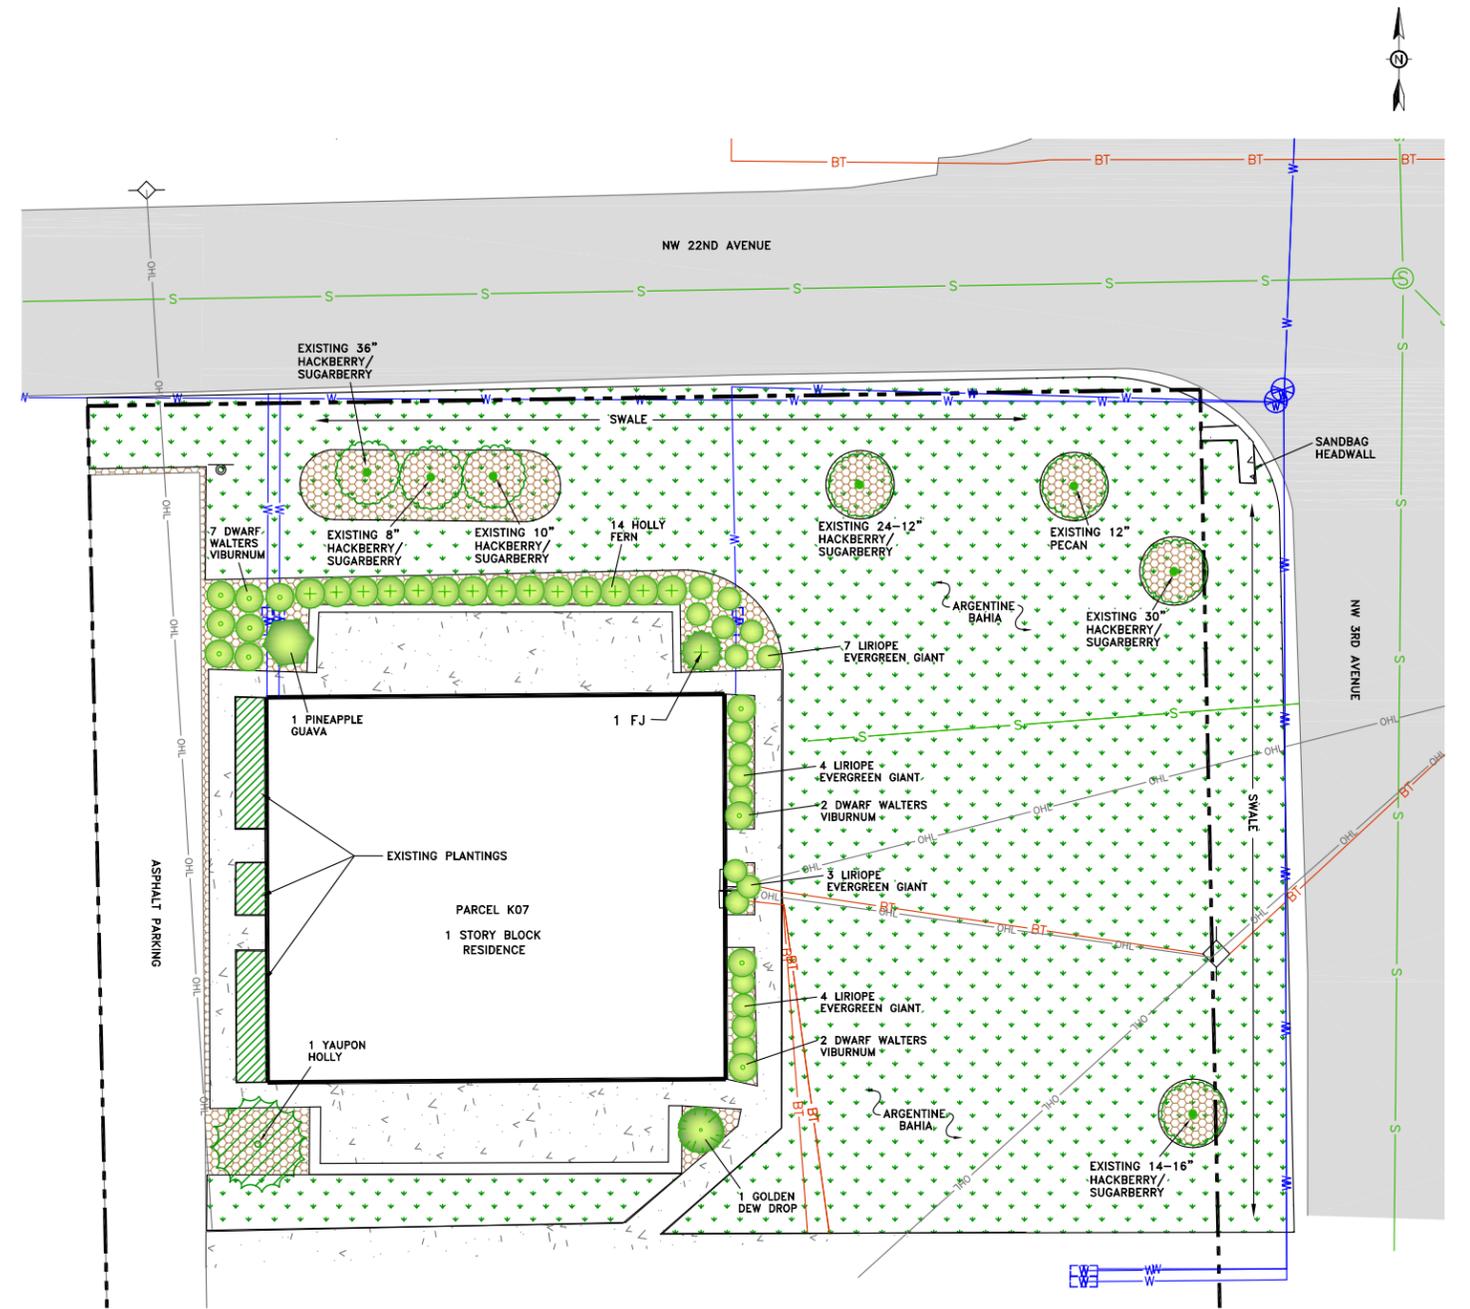
APPROVED	GC	FIGURE
DRAFTED	CP	
PROJECT#	117-2201319	
DATE	8-12-14	3-3

EXISTING CONDITIONS AND SOIL REMOVAL PLAN

RESTORATION PLAN

- LEGEND**
- PROPERTY LINE
 - BRUSH OR RAKE TOPSOIL TO ROOT MAT. REPLACE IMMEDIATELY. AREA = 2,100 S.F.
 - 1 FT SOIL REMOVAL AREA AREA = 5,285 S.F.
 - PROPERTY SETBACK
 - LIMITED EXCAVATION WITHIN 2 FT OF PERMANENT BUILDINGS
 - LIMITED EXCAVATION WITHIN 1 FT OF PAVEMENT
 - SHRUB TO BE REMOVED
 - TREE OR SHRUB TO BE REMOVED
 - TEMPORARY BENCHMARK
 - PRE-CONSTRUCTION SURVEY DATA TOPOGRAPHIC CONTOUR
 - TREE TO BE PROTECTED WITH PROTECTION RADIUS AND TREE PROTECTION AREA
 - UTILITIES**
 - OHW OVERHEAD UTILITY LINES
 - SS UNDERGROUND SANITARY SEWER (APPROX.)
 - WM UNDERGROUND WATER MAIN (APPROX.)
 - GAS UNDERGROUND NATURAL GAS (APPROX.)
 - BT UNDERGROUND TELEPHONE (APPROX.)
 - EL UNDERGROUND ELECTRIC (APPROX.)
 - UNK UNDERGROUND UNKNOWN (APPROX.)
 - SILT FENCE OR STRAW WATTLES DURING WORK LENGTH = 215 FT
 - HIGH VISIBILITY FENCE DURING WORK LENGTH = 215 FT
- 0 10 20
SCALE IN FEET

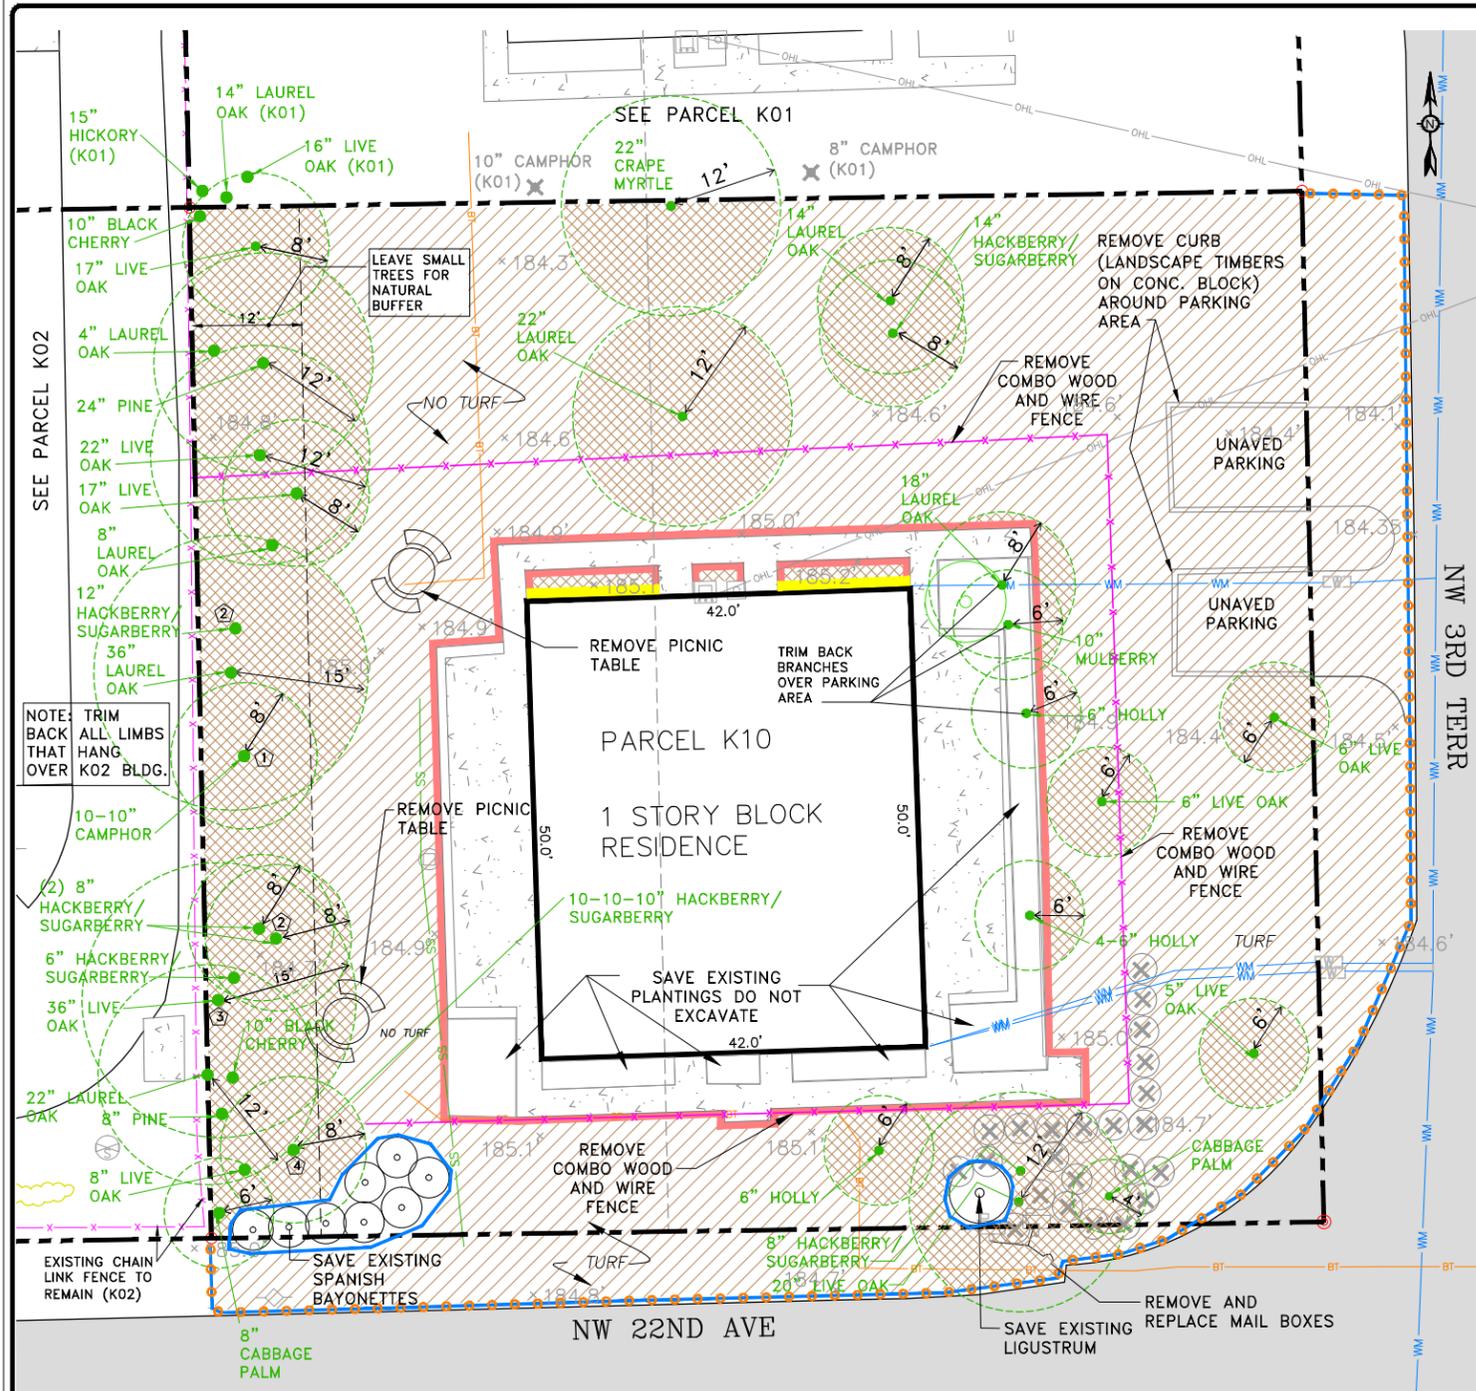
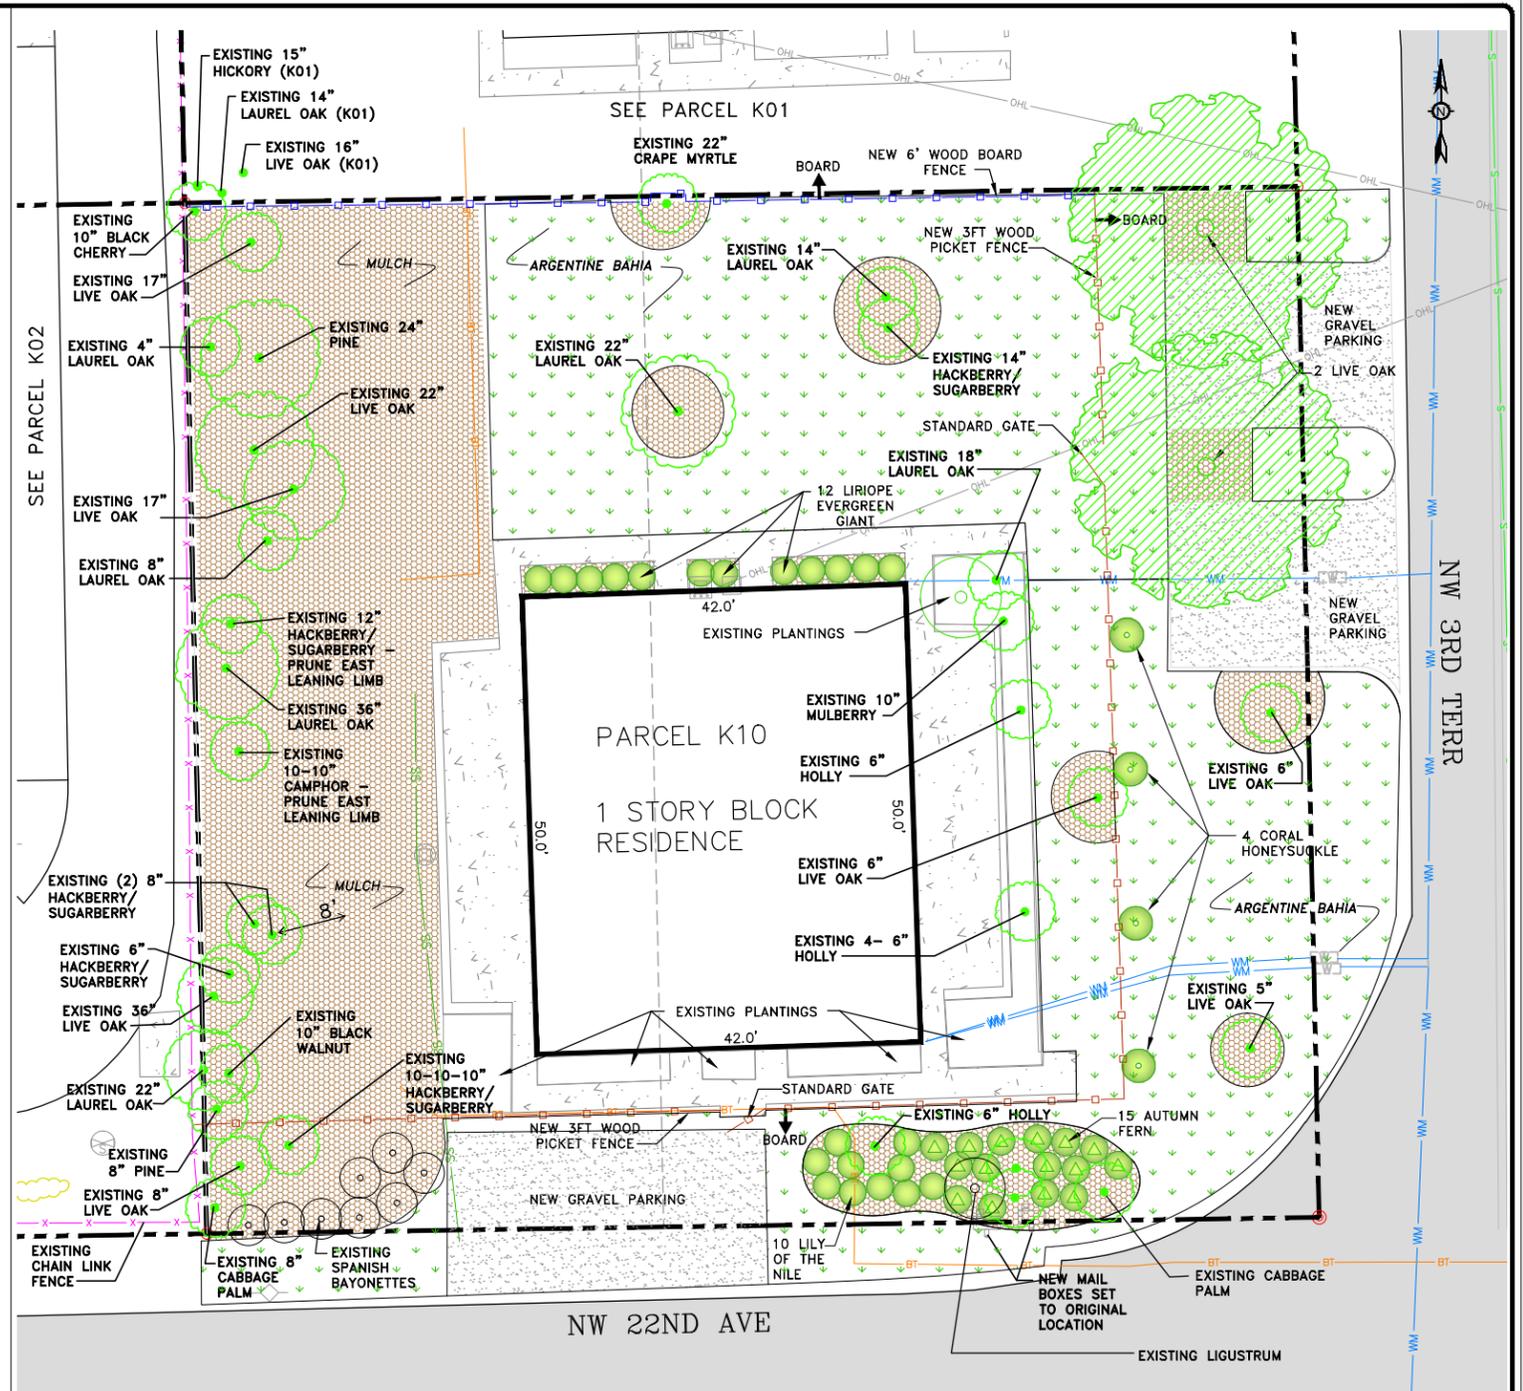
APPROVED	GC	FIGURE
DRAFTED	RMK	3-4
PROJECT#	117-2201319	
DATE	08-19-2014

- PROPERTY LINE
- BRUSH OR RAKE TOPSOIL TO ROOT MAT. REPLACE IMMEDIATELY. AREA = 3,500 S.F.
- 1 FT SOIL REMOVAL AREA AREA = 7,100 S.F.
- EXISTING COMBO WOOD AND WIRE FENCE REMOVE AND REPLACE WITH 3' WOOD PICKET FENCE

- GRAVEL DRIVEWAY AREA = 1,600 SF
- ARGENTINE BAHIA
- PINE BARK MULCH
- PROPERTY LINE
- NEW 3' PAINTED WHITE WOOD DOG EARED PICKET FENCE LENGTH = 200 FT.
- NEW 6' WOOD BOARD FENCE LENGTH = 100 FT.
- NEW TREE
- NEW TREE OR SHRUB
- EXISTING TREE
- UTILITIES
 - OHL - OVERHEAD UTILITY LINES
 - D - UNDERGROUND STORM DRAIN (APPROX.)
 - SS - UNDERGROUND SANITARY SEWER (APPROX.)
 - WM - UNDERGROUND WATER MAIN (APPROX.)
 - GAS - UNDERGROUND NATURAL GAS (APPROX.)
 - BT - UNDERGROUND TELEPHONE (APPROX.)
 - BE - UNDERGROUND ELECTRIC (APPROX.)
 - UNK - UNDERGROUND UNKNOWN (APPROX.)
