March 31, 2008

# Subject: Phase I ISBS - Field Pilot Study Report Cabot Carbon/Koppers Superfund Site in Gainesville, Florida Adventus Project No. AAI6-189

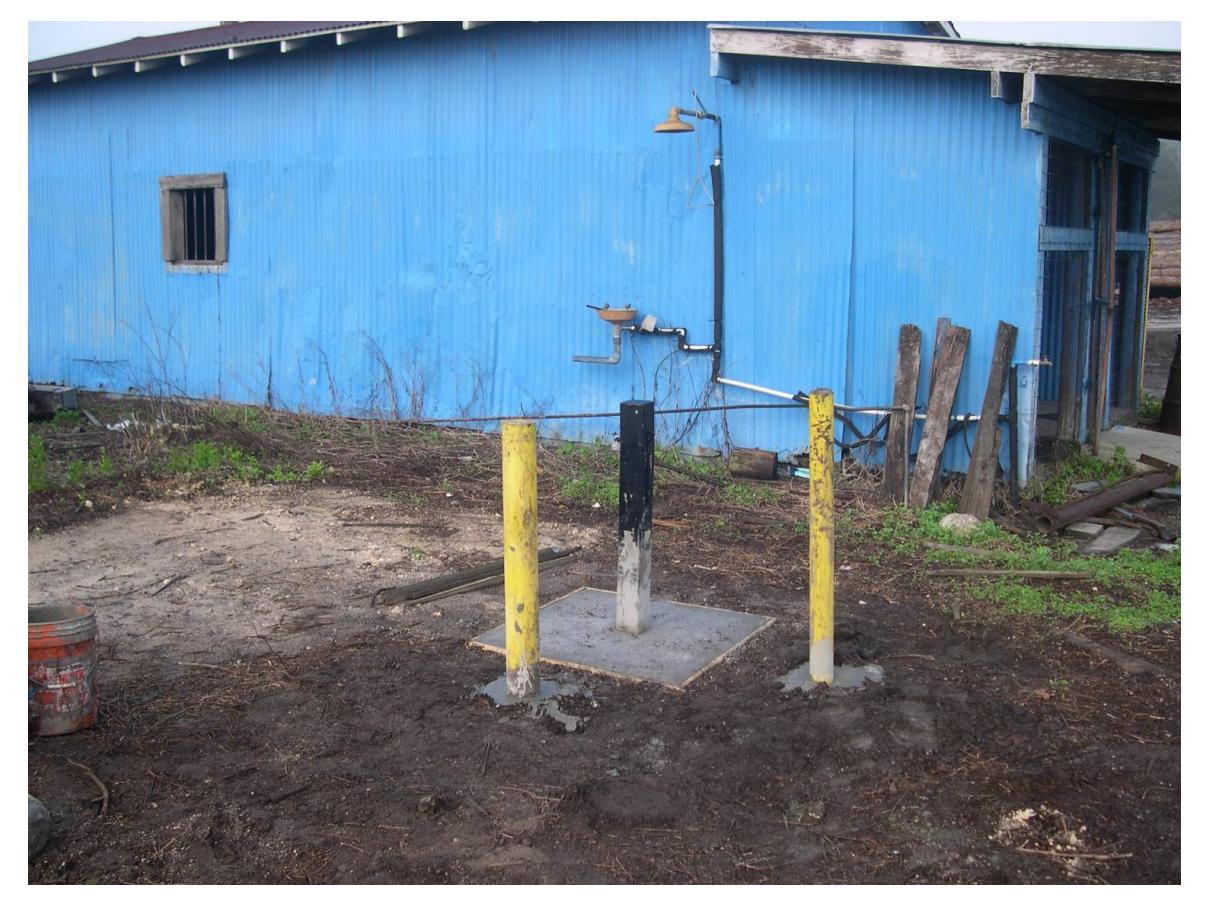
Figure 4. ZOD-1 Completion Photo

In accordance with the Florida Department of Environmental Protection (FDEP) Final Order Granting a Variance (FDEP, 2008), an additional monitoring well was installed on January 22, 2008 in the surficial aquifer approximately 150 feet downgradient of the ZOD, where injections were performed. The monitoring well, designated ZOD-1, is shown on **Figure 3**. A boring log and well construction log are included in **Appendix F**, and a photo of the completed well is shown as **Figure 4**. Following its installation, ZOD-1 was developed by pumping 160 gallons of water from the well at a flow rate of approximately 2.5 gpm. This was also conducted on January 22, 2008.

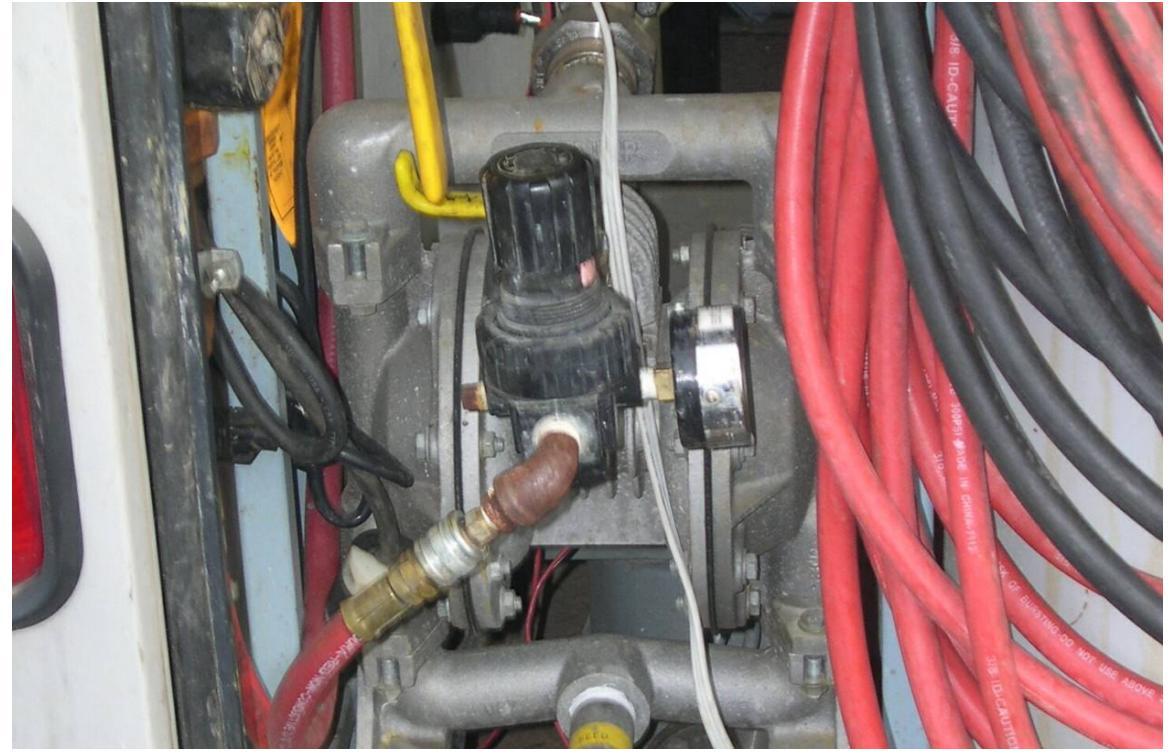
- The final number of DIP borings increased from a planned 10 to 16 (Figure 2).
- A small air-diaphragm pump was used to keep the injection flow rate as low as practical (**Figure 5**). Injection pressures generally ranged between 25 and 75 psi and were adjusted to achieve minimal maintainable flow rates, which ranged from approximately 2 to 10 gallons per minute (gpm), and averaged about 6 gpm. The air diaphragm pump was an essential piece of equipment, given the relatively high solids and low flow rate requirements of the job.

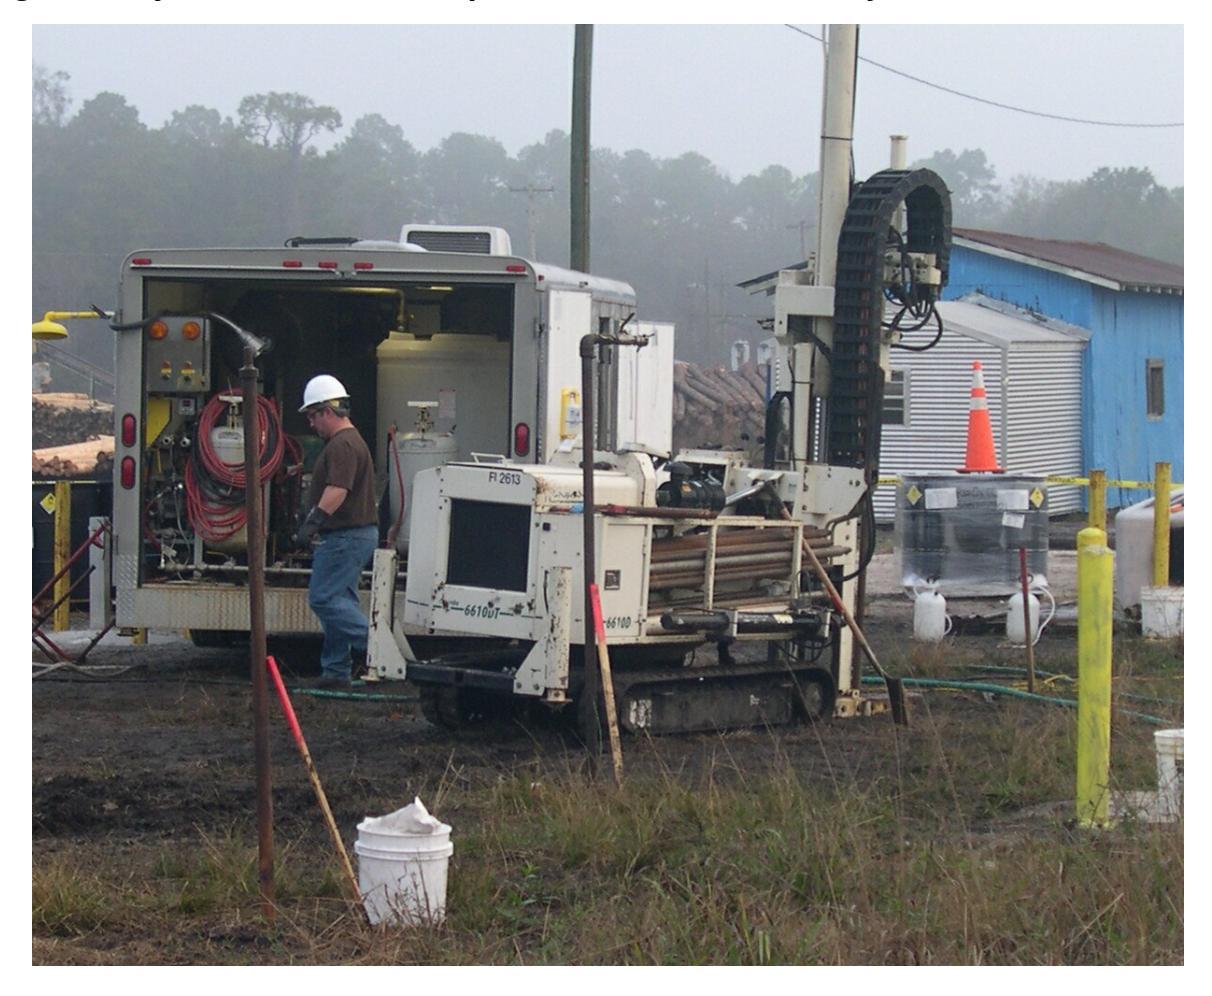
## Figure 6. Injection Rods at Multiple Locations Concurrently

- Injections were completed using multiple rods in the ground concurrently (Figure 6 – note multiple pipes in ground with valves closed). This was done to allow pressure to safely dissipate before pulling the tooling up to the next interval at a given location.
- In addition to the use of air pulses as described in the IET report, short air pulses were occasionally used at the first indication of daylighting (i.e., injectate coming to the surface). This worked particularly well at location DIP-5S, where the air pulse effectively terminated the daylighting, and allowed the injection to be completed.

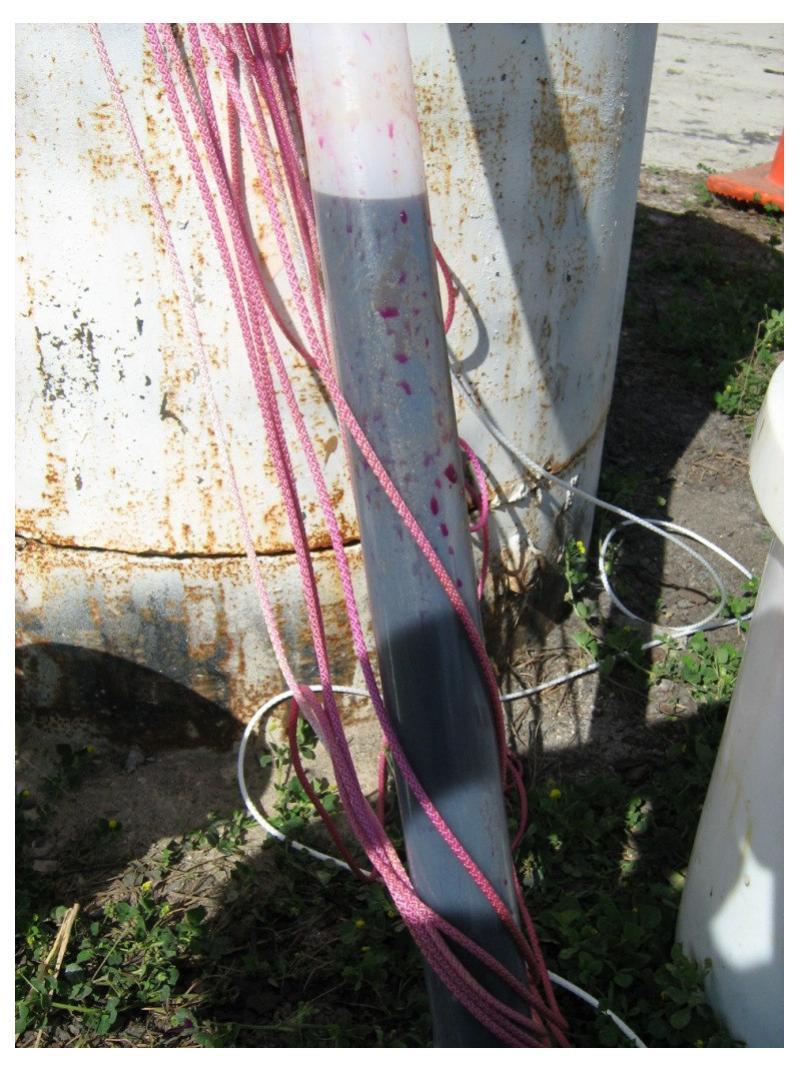
# Figure 8. Water in UHG-EW-01 Following Injections

Attached is a photo of the water in UHG-EW01. HG-10S, HG-10D, HG-18S, and HG-19S (all in close proximity to UHG-EW01 and injection area) contain no signs of purple.

A photo of the water in UHG-EW-01 is included as **Figure 8**, and relevant well logs are included as **Appendix M**. The recovery well log (i.e., UHG-EW-01) shows the clay at the base of the surficial aquifer to be 2 to 2.5' thick, with a sand intrusion. It also shows that a surface casing was set into this clay and that all casings were

Water appearance was normal at ISBS-1&2. There was no water in TIP-4 (only purple sludge). The water in TIP-3 was purple with purple sludge at 9.10 feet. When I gauged UHG-EW01 (Key well) the entire water column was stained purple. The well screen in this well is located from 54.5 feet to 59.5 feet. This is a 64 foot deep extraction well. HG-10S did not have any purple stain and appeared normal with DNAPL in the bottom foot of the well.

Thus, it shows no clear pathway for the RemOx EC to reach the Upper Hawthorne Group from the surficial aquifer. Some factors that may have enabled the RemOx EC to pass from the surficial aquifer into the Upper Hawthorne Group in this area may include:

- The thin clay with sand intrusions and oxidized mineral faces, is likely discontinuous. Note that the HG-18s/HG-19s log seemingly shows the clay to be only 6" thick.
- The relatively high density of the RemOx EC solution and evidence from the VBs that it followed the clay (discussed above), coupled with the presence of NAPL and tarry materials within the zone of injection may have effectively resulted in preferential flow paths towards discontinuities in the clay.

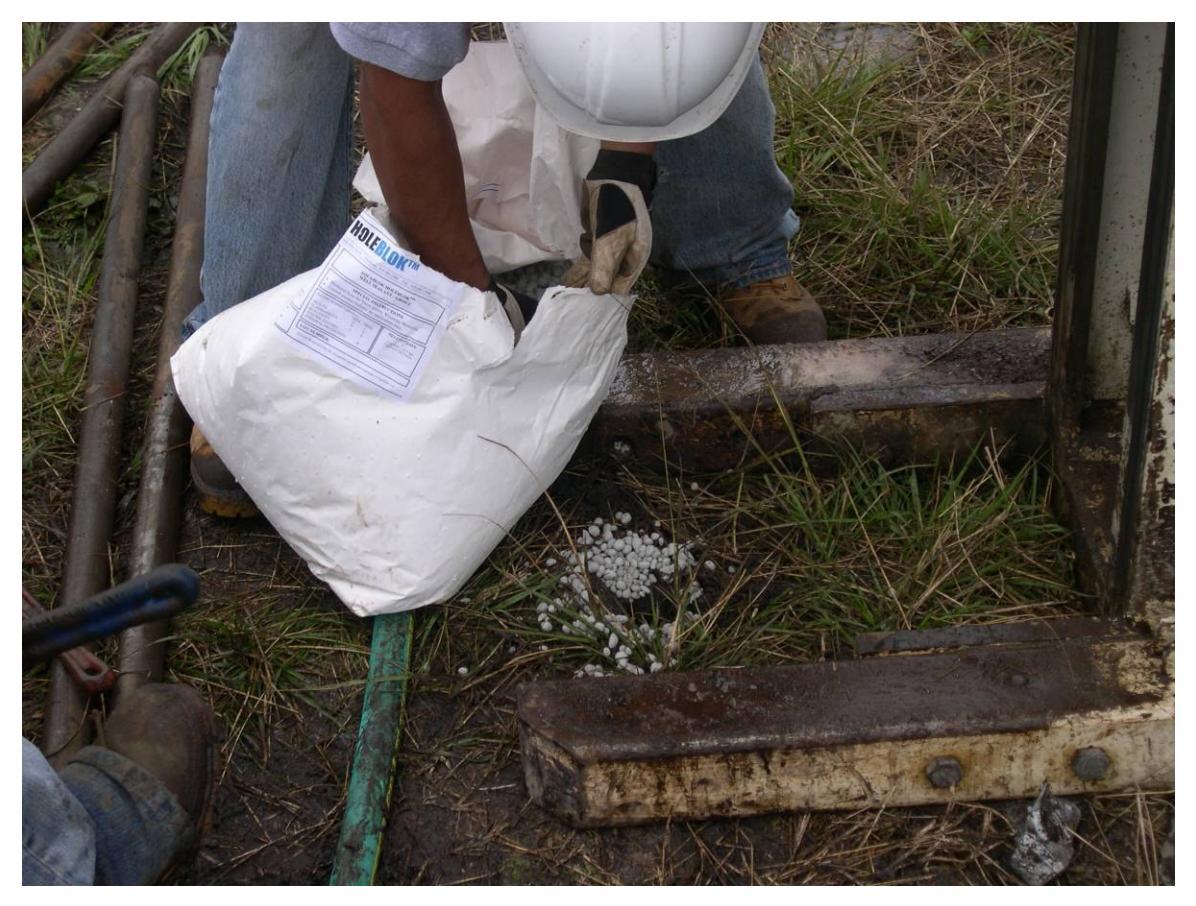
#### Figure 9. HoleBlok Addition to a DIP Boring

All of the various borings conducted as part of the January 2008 work were properly abandoned. The DIP borings and DB-3 were abandoned using standard bentonite chips and/or HoleBlok. A photo of the HoleBlok being added to a boring is included as **Figure 9**, and an information sheet on the product is included as **Appendix N**. A total of 11 bags of HoleBlok and 2 bags of bentonite chips were used in the course of abandoning these borings. The verification borings were generally abandoned using neat cement, with the exception of VB-1. VB-1 was partially filled with bentonite chips, and neat cement grout was utilized from the top of the chips to the surface.
